**CASTLE BEACH
CLUB CONDO**
UCI Project No. 0408-121

UCI ENGINEERING, INC.
CASTLE BEACH CLUB CONDO
UCI Project No. 0407-121
FIELD INSPECTION REPORT No. 1

To:	Mr. Leo Gonzalez, President for Castle Beach Club Condo Association	Report Date:	September 20 th , 2004
From:	Oscar Castells	Visit Date:	August 18 th , 2004
Project:	CASTLE BEACH CLUB CONDO	Address:	5445 Collins Avenue
Proj. No:	0407-121		Miami Beach, Florida
Ref.:	INFRARED SURVEY OF EXISTING BUSDUCTS AND SWITCHGEAR

To:	Mr. Leo Gonzalez	Report Date:	November 16 th , 2004
From:	Oscar Castells	Visit Date:	November 5 th , 2004
Project:	CASTLE BEACH CLUB CONDO	Address:	5445 Collins Avenue Miami Beach, Florida
Proj. No:	0407-121		
Ref.:	RECOMMENDATIONS REGARDING EXISTING BUSDUCTS, SWITCHGEAR AND MOTOR CONTROL CENTERS

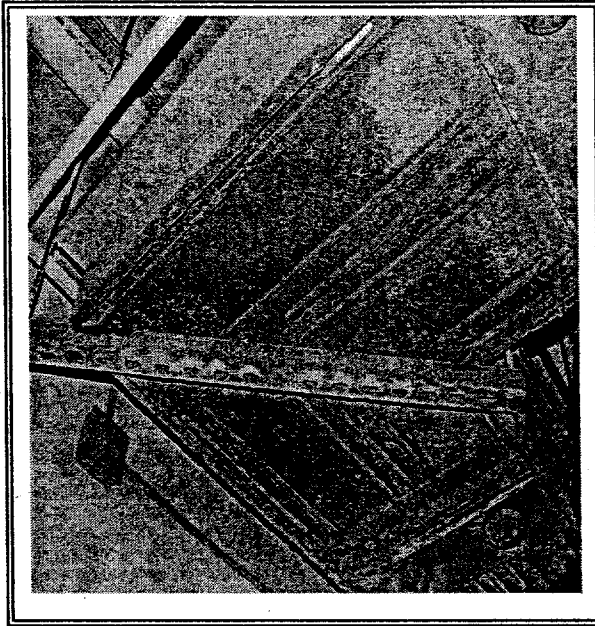
The effect of water old spillages is easily noticed on the three larger circuit breakers (4000A, 4000A and 2500A) that have their exterior covers stained by water. One of the lateral covers of the 2500A circuit breaker was removed and the interior showed no signs of water penetration.

The 2500A bus-way cover has an angle heavily rusted (approximately 4' long against approximately 20' inside the main switchgear room).

Photo No. 1: Main Switchgear Room
See rust

Cleaning and painting of the devices covers (sometimes even replacement in a minor extent) is obviously required, together with laboratory tests of the functional aspects of the devices (overload and fault tripping for the breakers and isolation level for the bus-ways).

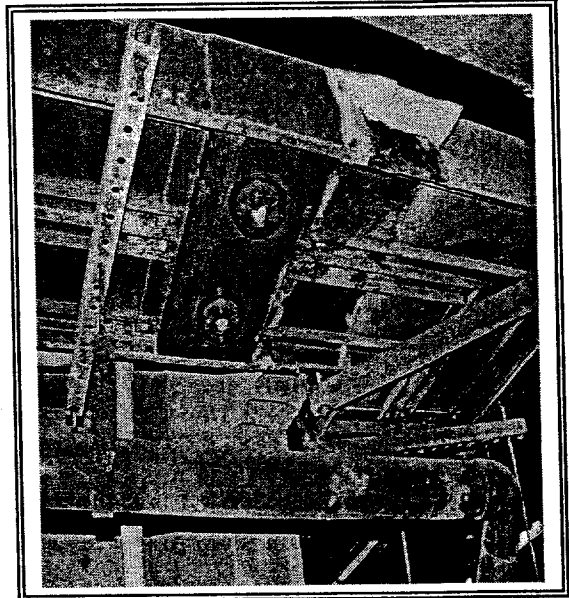
Photo No. 6
See rust and against code installation

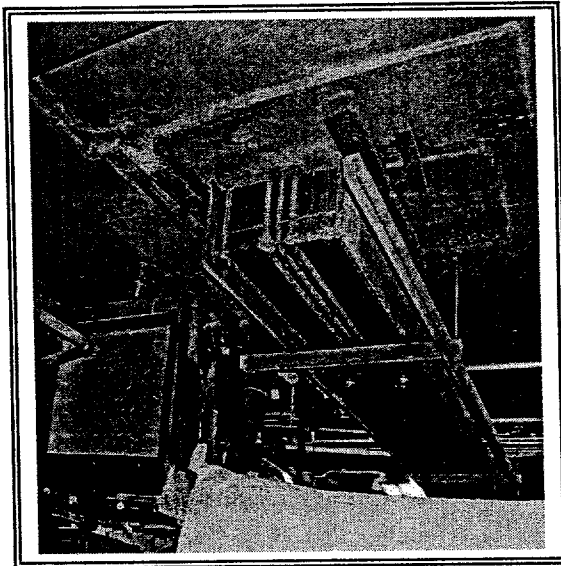
Photo No. 7:
See signs of old leaks

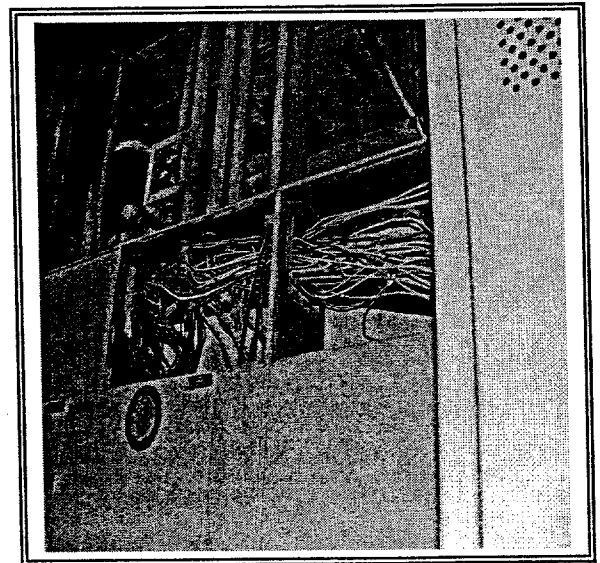
There are three MCC in the electromechanical area in the lower lobby level are. Two of them installed back to back have several cubicles abandoned, and a few cubicles in use but without cover and with wires exposed.

Photo No. 8
Covers required

Also the open cubicles must be covered and the through slab penetrations must be water sealed appropriately.

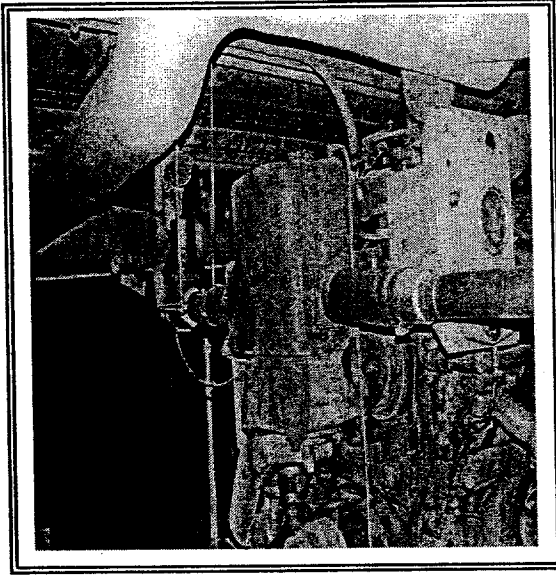
The emergency generator room is located in a poorly ventilated room in the basement garage level. The emergency generator cooling system consists in a direct connection to a water main pipe, with no apparent water recirculation.

Photo No. 9
Generator Cooling Water Connection

A two-hour full load test of the generator is recommended to verify the sufficiency of the described cooling system.

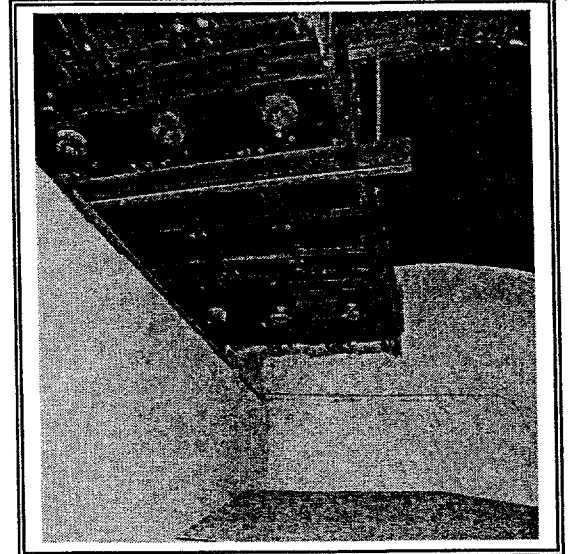
Photo No. 12
See rust signs

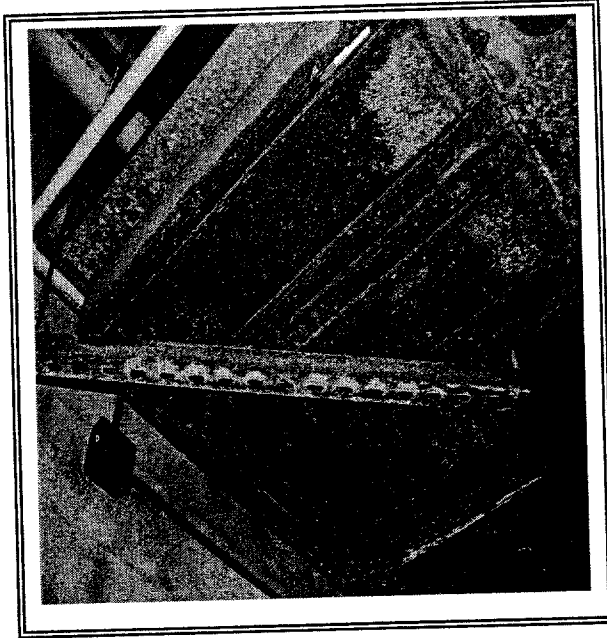
Photo No. 1: Main Switchgear Room
See rust

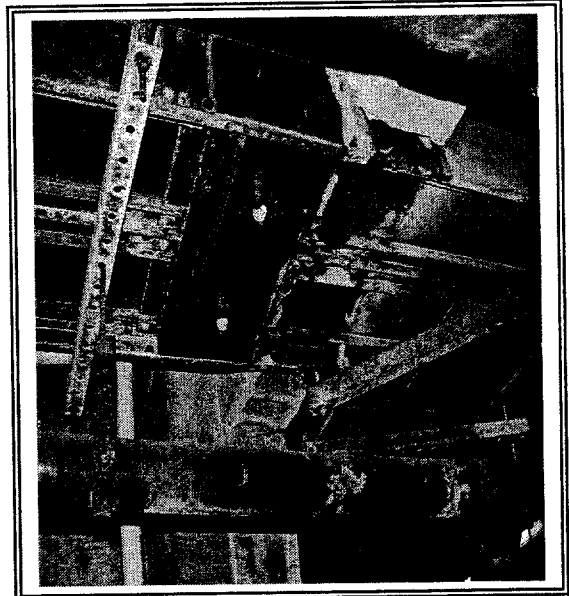
Photo No. 6
See rust and against code installation

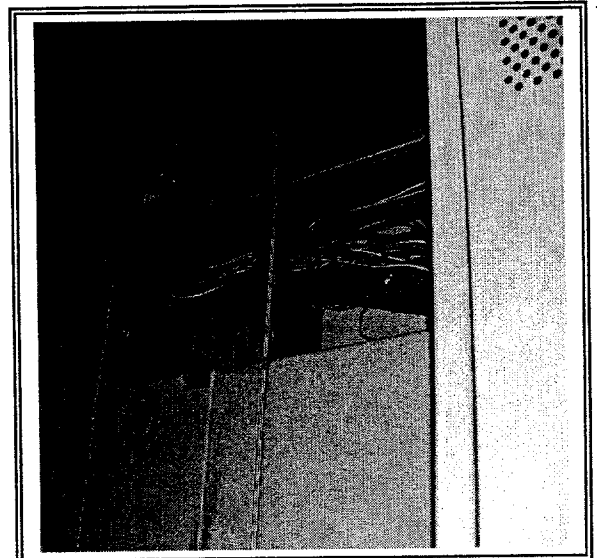
Photo No. 8
Covers required

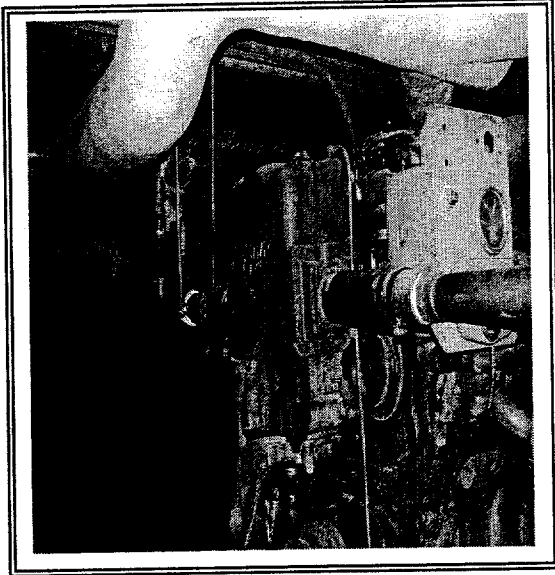
Photo No. 9
Generator Cooling Water Connection

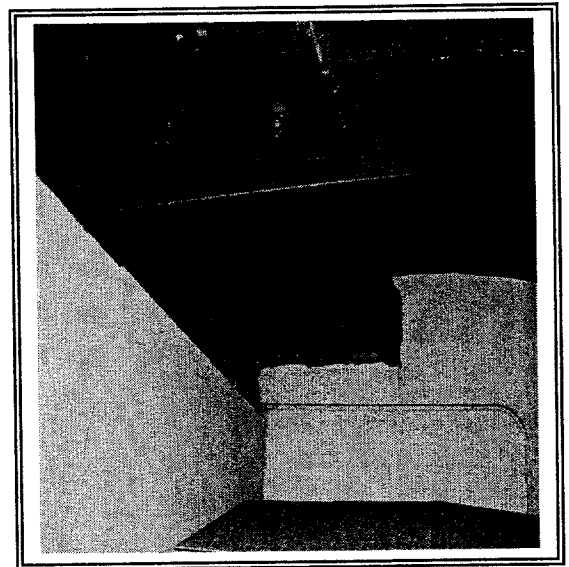
Photo No. 12
See rust signs

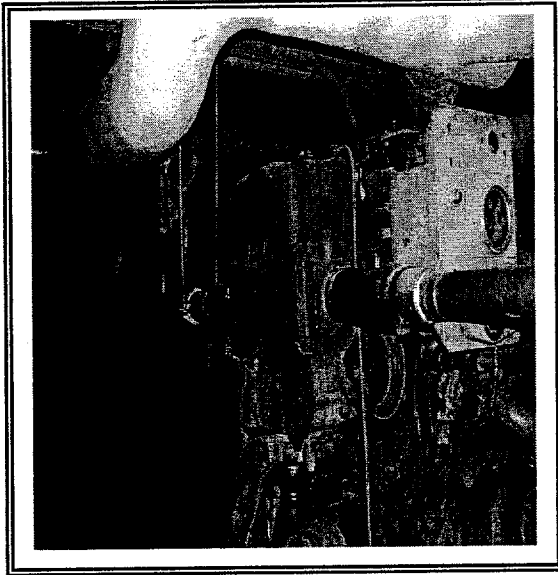
Photo No. 9
Generator Cooling Water Connection

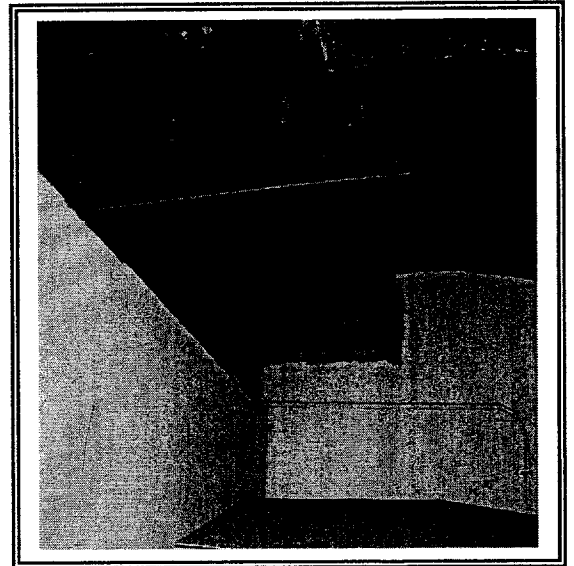
Photo No. 12
See rust signs

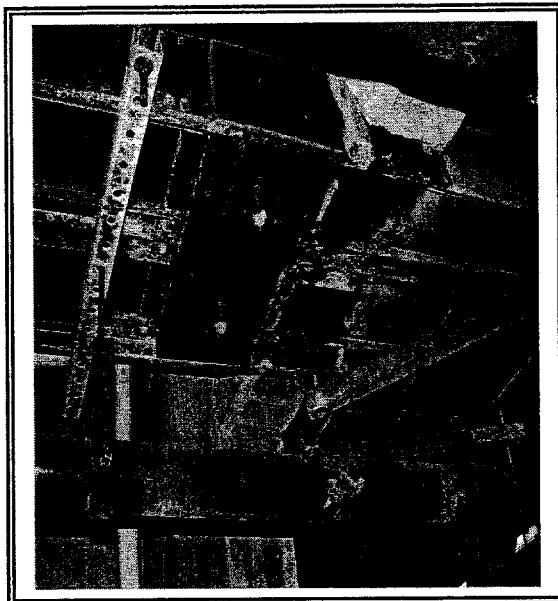
Photo No. 6
See rust and against code installation

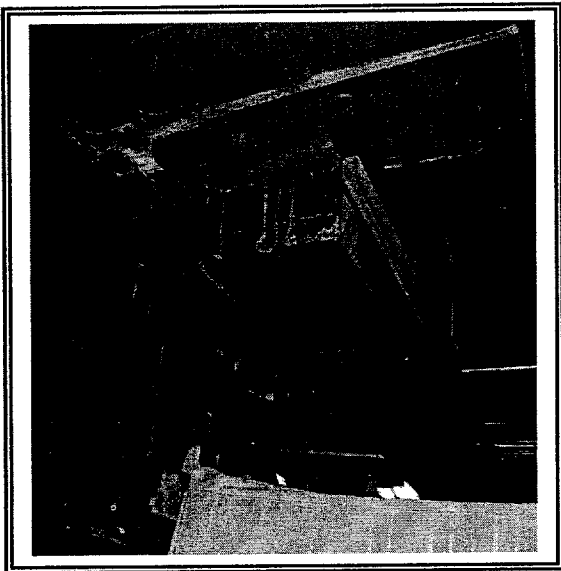
Photo No. 7:
See signs of old leaks

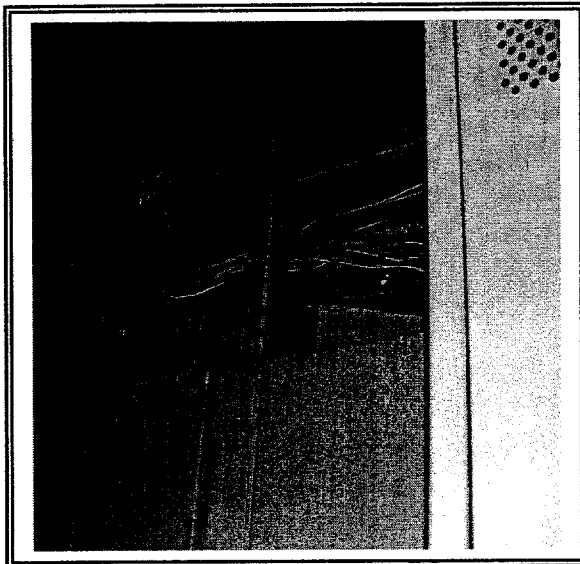
Photo No. 8
Covers required

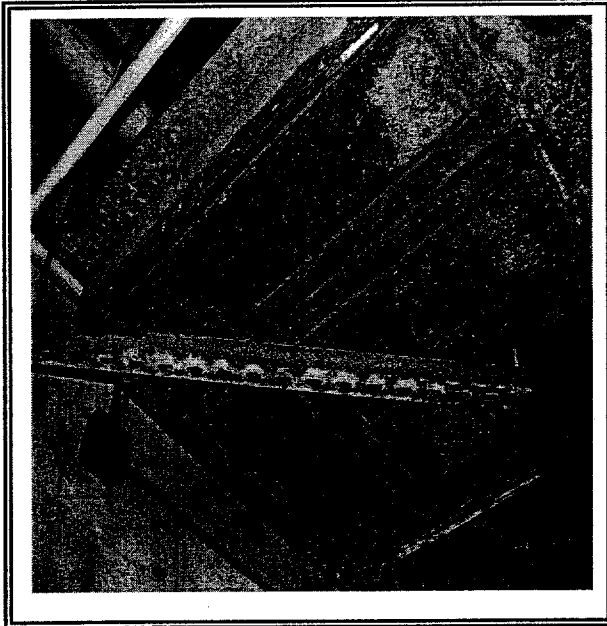
Photo No. 1: Main Switchgear Room
See rust
